<b>Project Name:</b> Gold King Mine	<b>Site Location:</b> Silverton, San Juan County, Colorado	<b>Project No.</b> 0001/1408-01
--	---	------------------------------------

## PHOTOGRAPH LOG

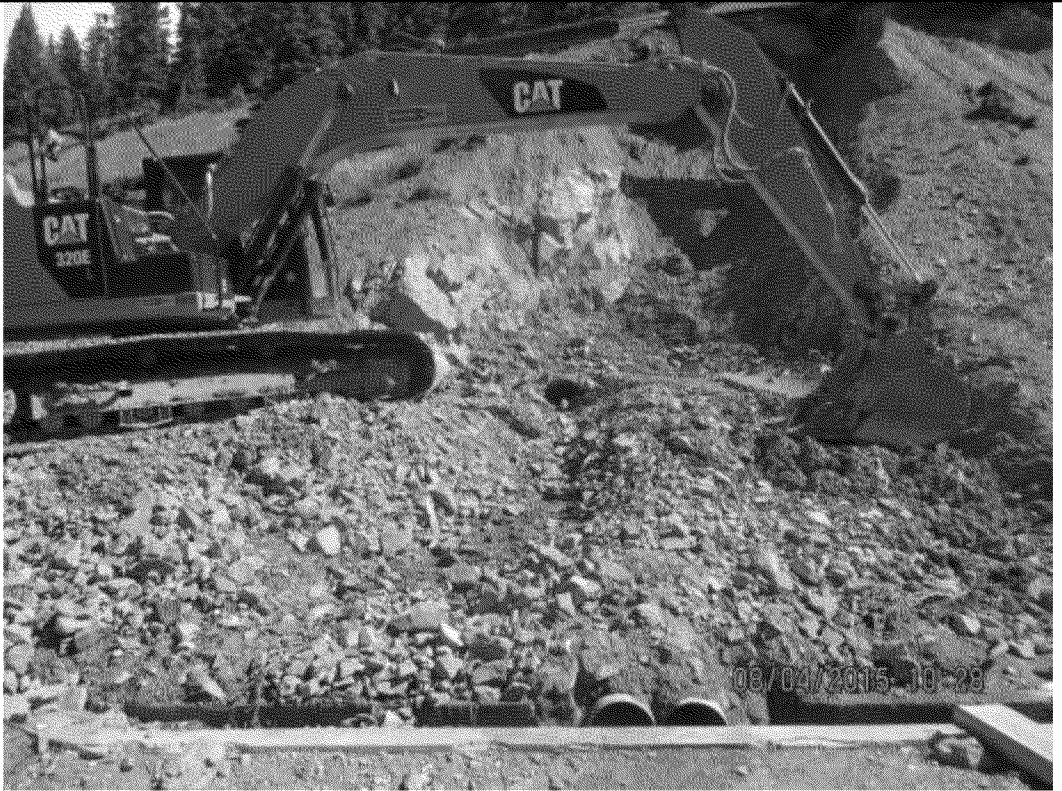
<b>Photo No.</b> 1	<b>Date:</b> 08/04/2015

<b>Direction Photo Taken:</b>  North		
<b>Description:</b> Beginning investigation into collapsed adit.

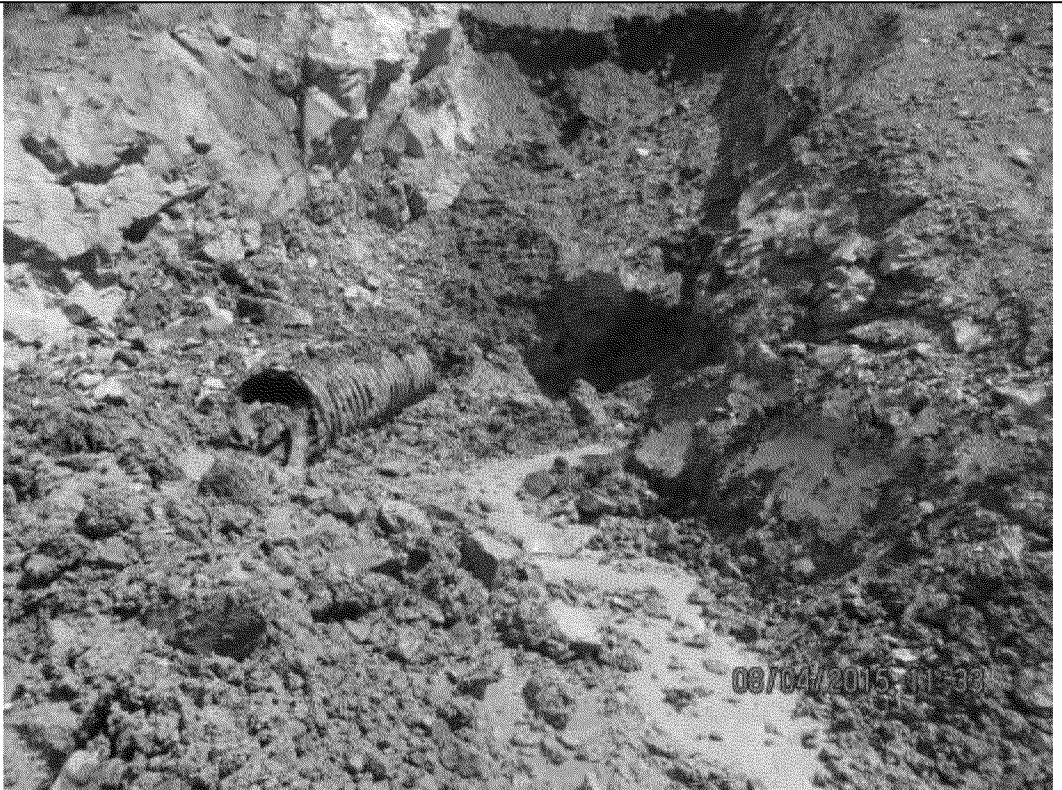
<b>Photo No.</b> 2	<b>Date:</b> 08/04/2015

<b>Direction Photo Taken:</b>  North		
<b>Description:</b> Excavated next to DRMS-installed culvert, water muddy from soil disturbance.

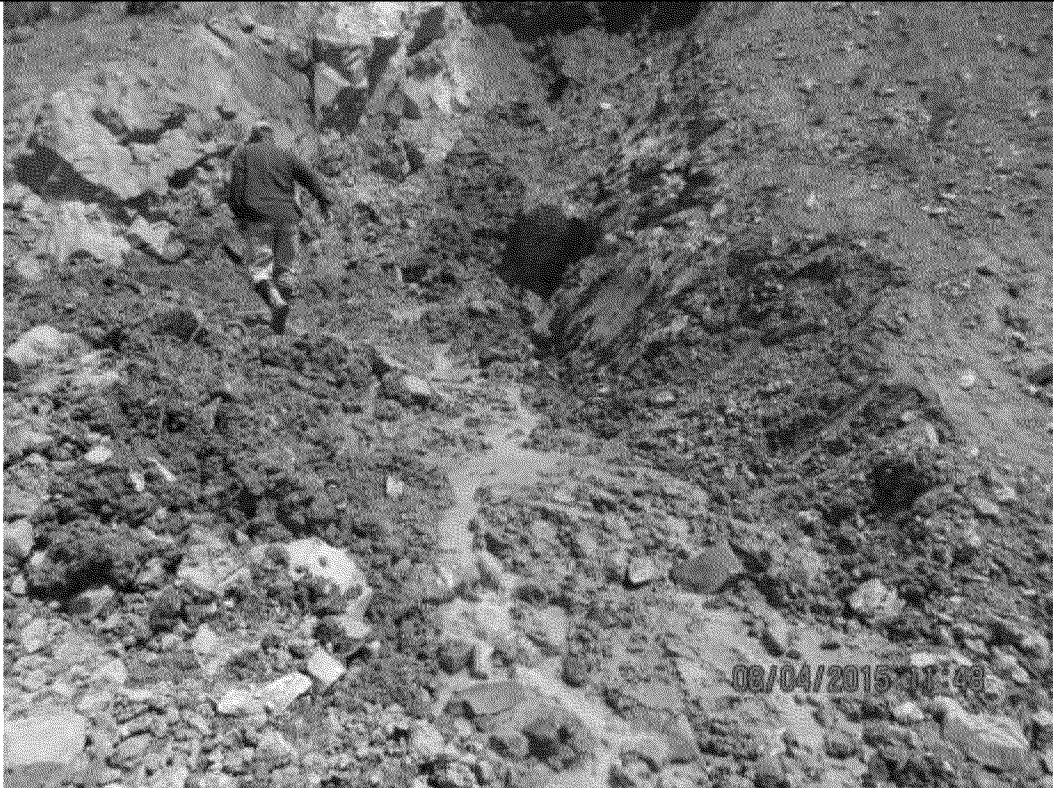
<p><b>Photo No.</b> <b>5</b></p>	<p><b>Date:</b> 08/04/2015</p>

<p><b>Direction Photo Taken:</b></p> <p>North</p>		
<p><b>Description:</b></p> <p>DRMS looking at adit excavation progress.</p>		
<p><b>Photo No.</b> <b>6</b></p>	<p><b>Date:</b> 08/04/2015</p>

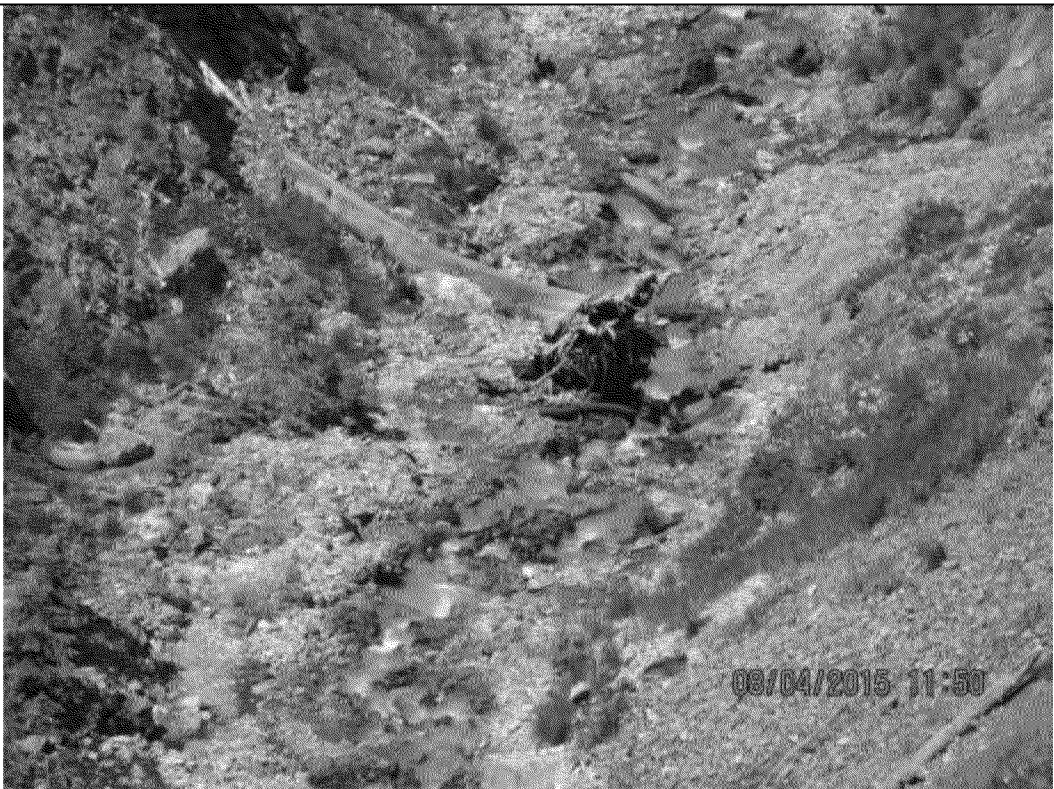
<p><b>Direction Photo Taken:</b></p> <p>West</p>		
<p><b>Description:</b></p> <p>Water minimally murky from disturbed soil and water entering the North Fork from site.</p>

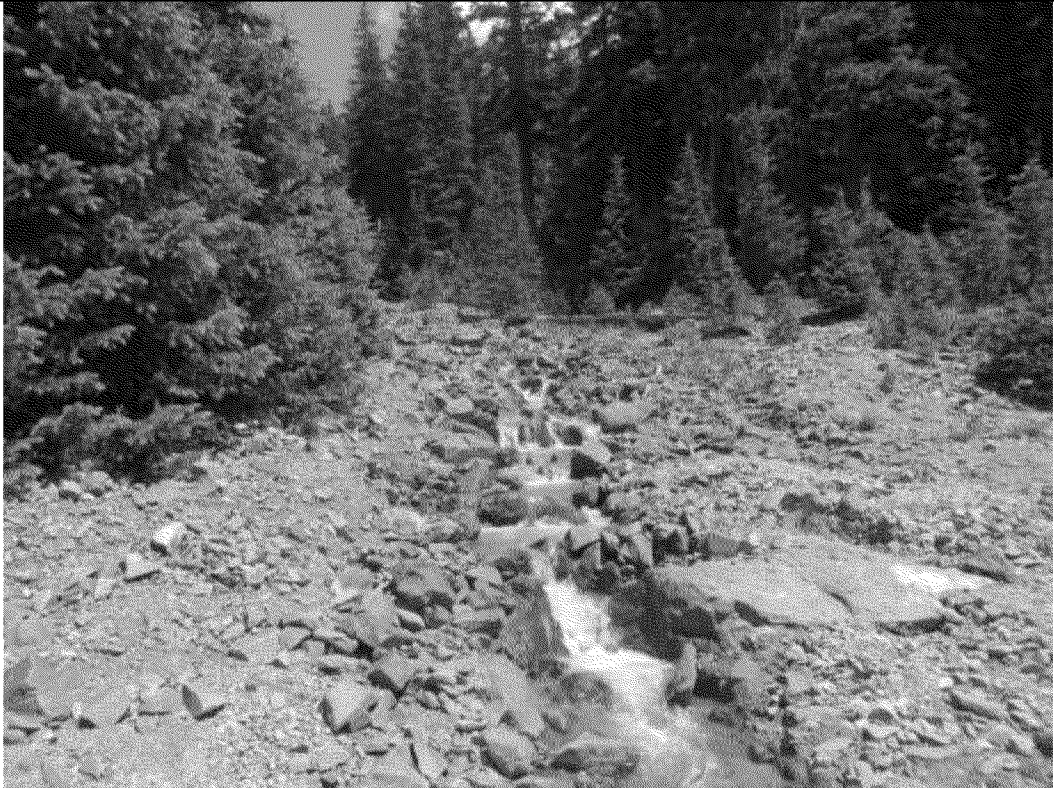
<p><b>Photo No.</b> <b>11</b></p>	<p><b>Date:</b> 08/04/2015</p>

<p><b>Direction Photo Taken:</b></p> <p>East</p>		
<p><b>Description:</b></p> <p>Water of the North Fork just upstream of Cement Creek.</p>		
<p><b>Photo No.</b> <b>12</b></p>	<p><b>Date:</b> 08/04/2015</p>

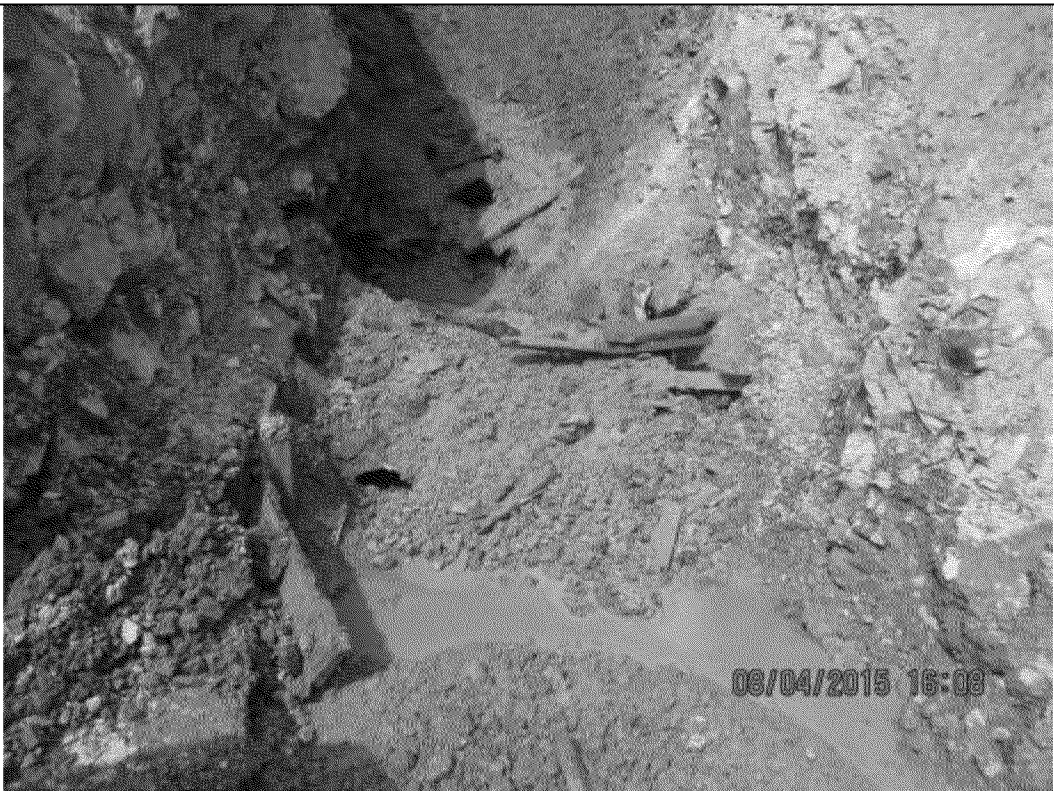
<p><b>Direction Photo Taken:</b></p> <p>North</p>		
<p><b>Description:</b></p> <p>Collapsed supports uncovered above anticipated adit, no sign of bedrock above the adit area.</p>

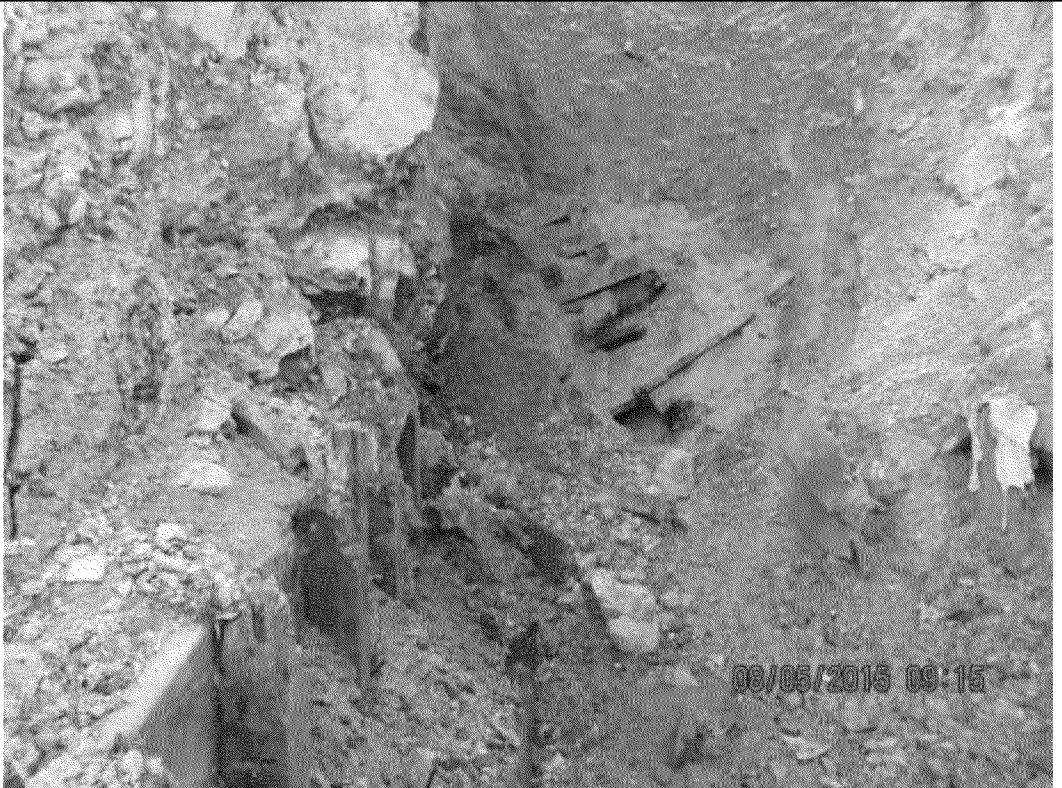
<b>Photo No.</b> 13	<b>Date:</b> 08/05/2015

<b>Direction Photo Taken:</b>  North		
<b>Description:</b> Adit conditions the morning of 8/5.		
<b>Photo No.</b> 14	<b>Date:</b> 08/05/2015

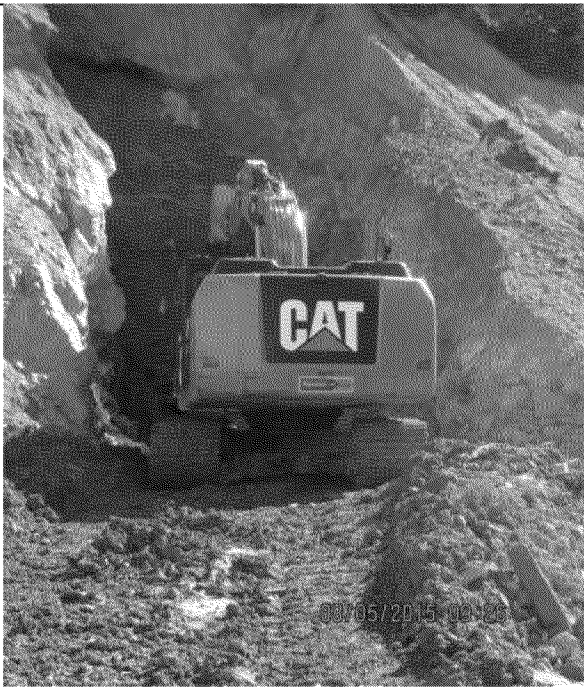
<b>Direction Photo Taken:</b>  Northeast		
<b>Description:</b> Excavating material above the collapsed adit.

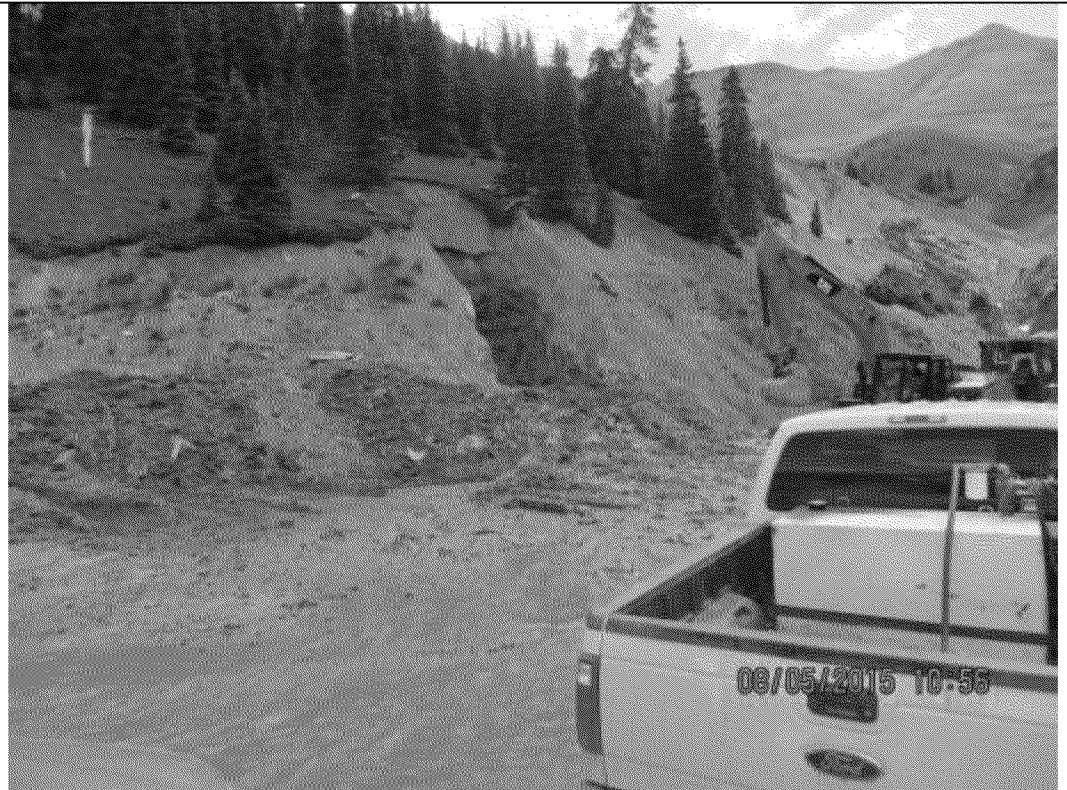
**Photo  
No.  
19**

Adit flow increasing.

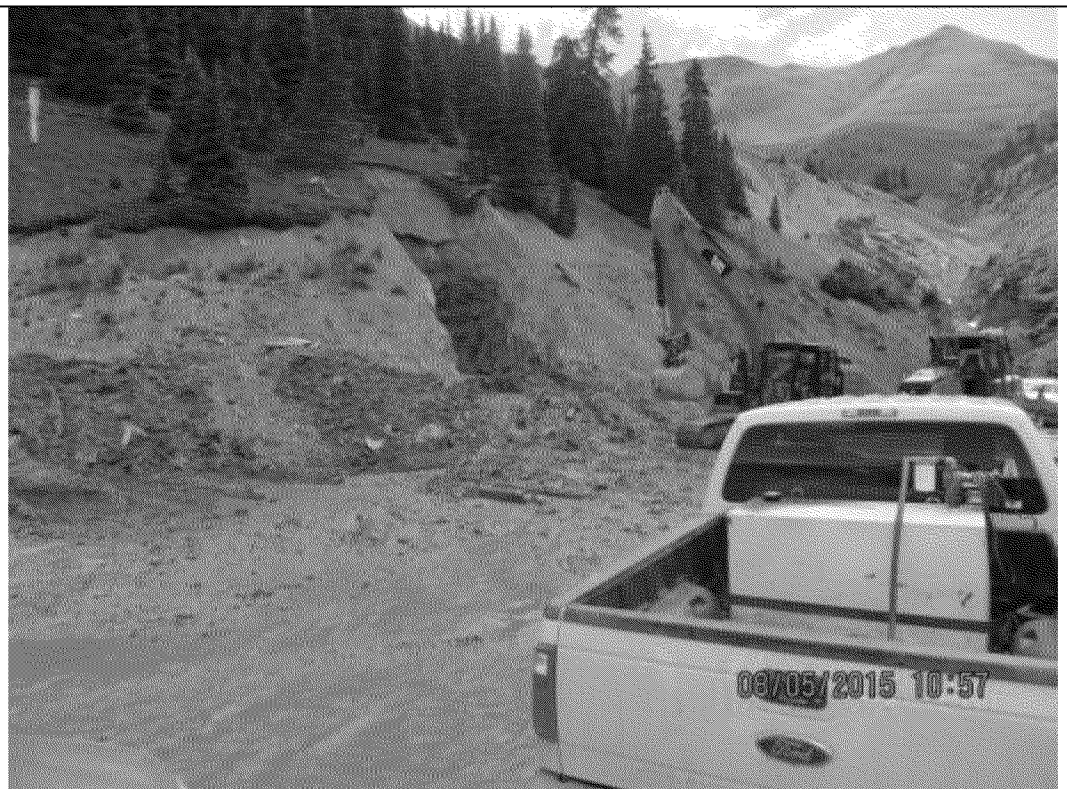
**Photo  
No.  
20**

Water flooding out at  
increased rate.

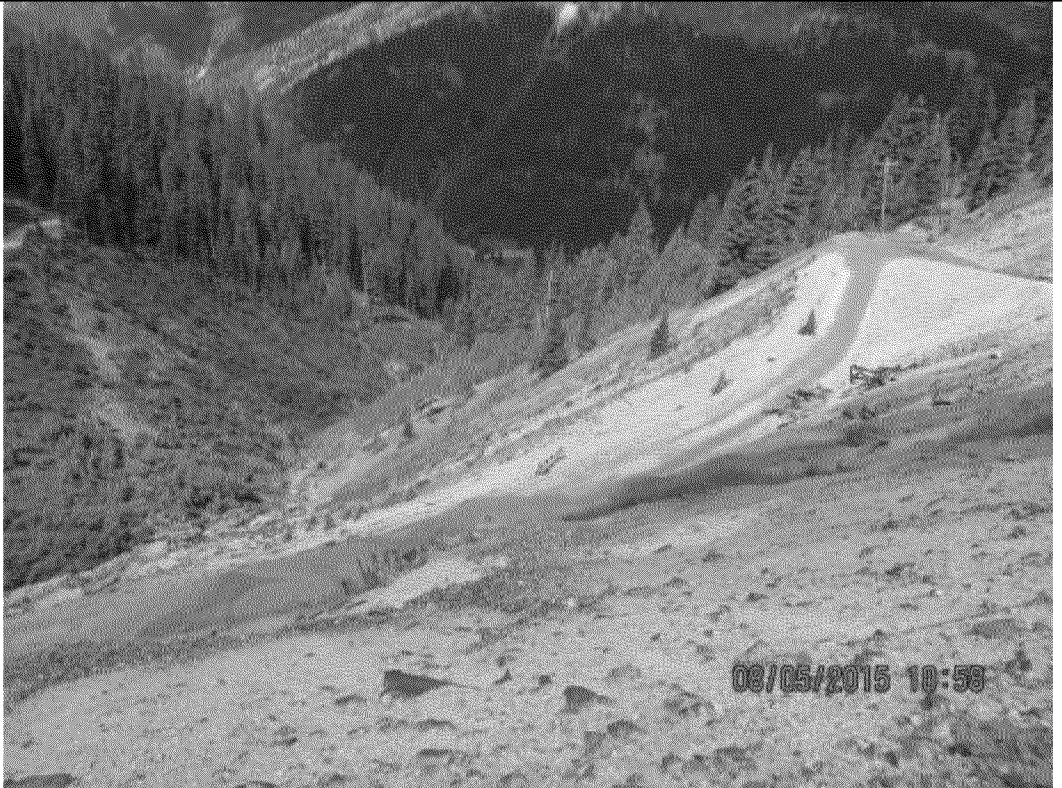
<b>Photo No.</b> <b>21</b>	<b>Date:</b> 08/05/2015

<b>Direction Photo Taken:</b>  West		
<b>Description:</b> Water flowing along access road and across waste dump.		
<b>Photo No.</b> <b>22</b>	<b>Date:</b> 08/05/2015

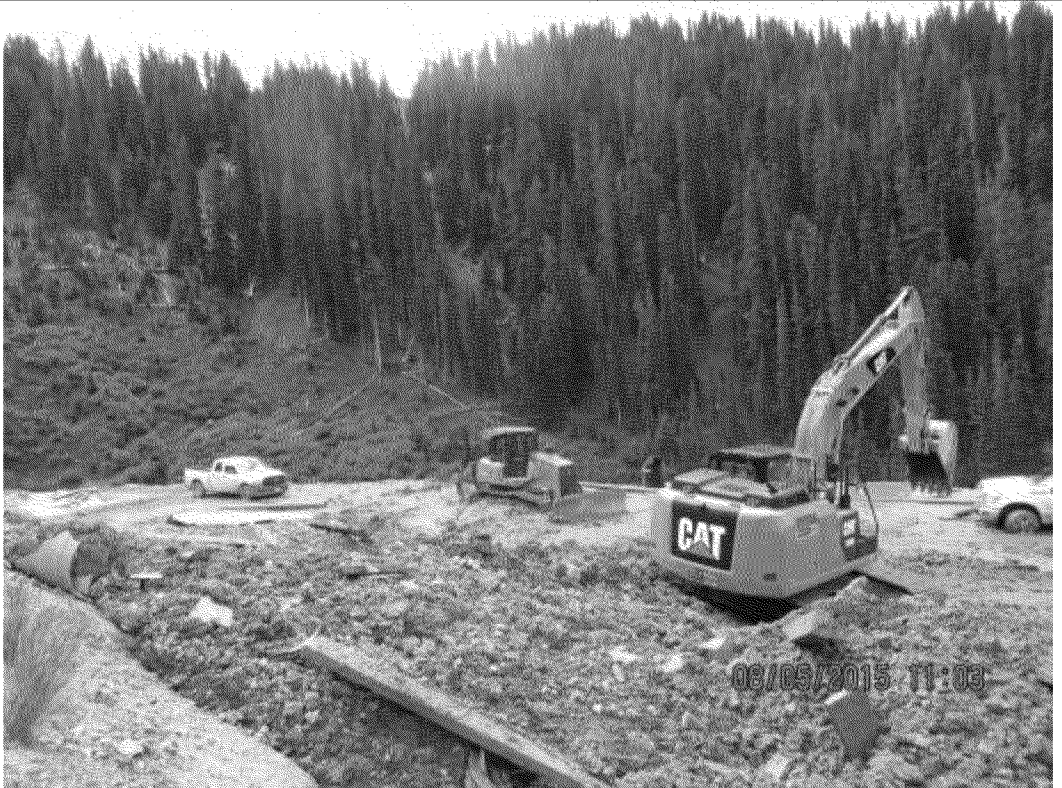
<b>Direction Photo Taken:</b>  Southeast		
<b>Description:</b> Water flowing over the edge of the waste dump and collapsing the edge.

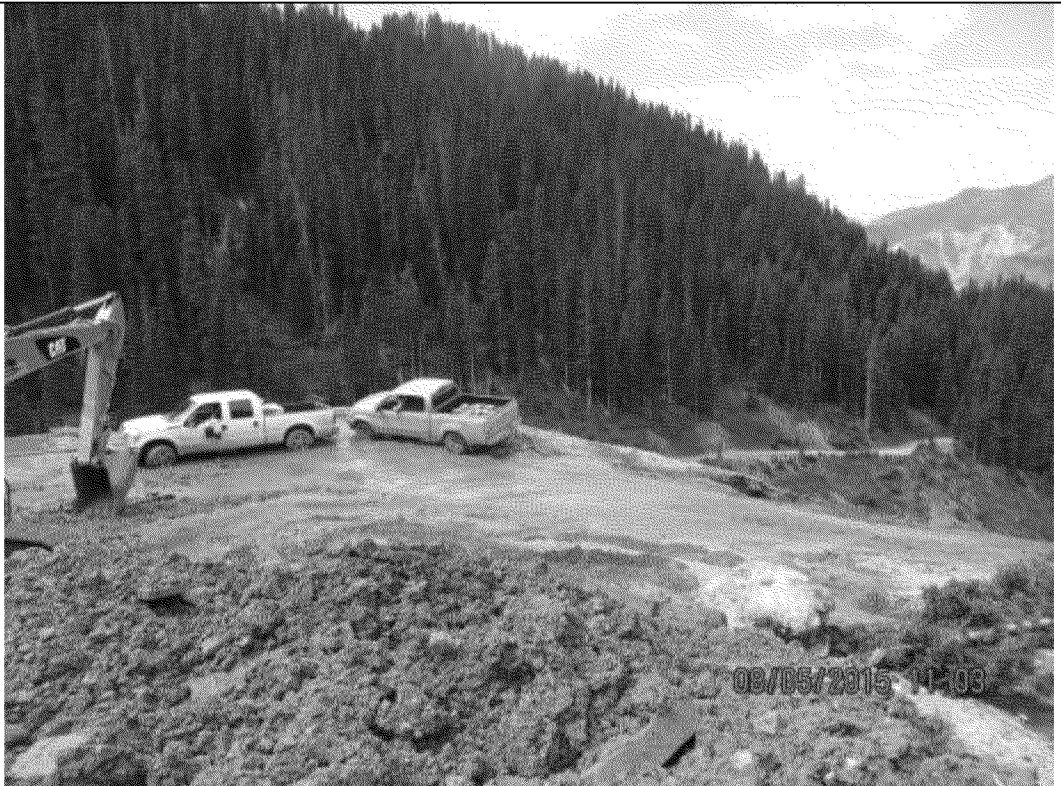
<b>Photo No.</b> <b>23</b>	<b>Date:</b> 08/05/2015

<b>Direction Photo Taken:</b>  Southwest		
<b>Description:</b> Exit route starting to collapse

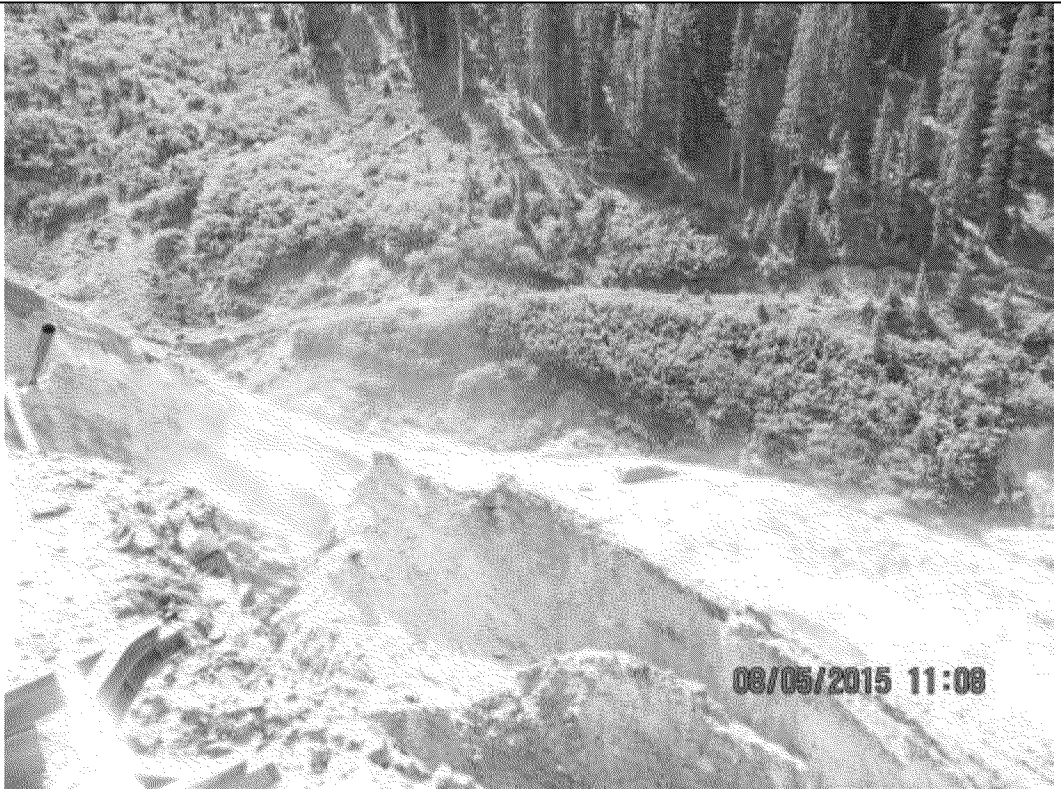
<b>Photo No.</b> <b>24</b>	<b>Date:</b> 08/05/2015

<b>Direction Photo Taken:</b>  Southeast/Down		
<b>Description:</b> Edge of the tailings dump collapsed, suburban trapped and half submerged in center of photo.

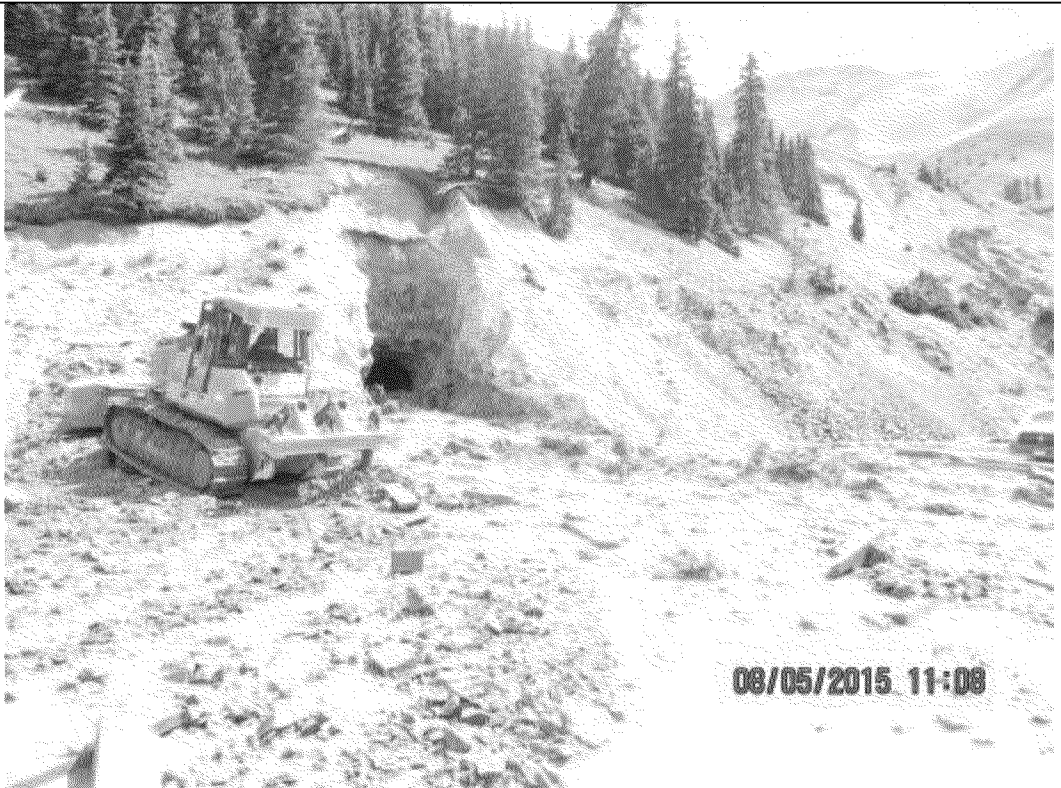
<b>Photo No.</b> <b>25</b>	<b>Date:</b> 08/05/2015

<b>Direction Photo Taken:</b>  Northeast		
<b>Description:</b> Gold King adit exposed.		
<b>Photo No.</b> <b>26</b>	<b>Date:</b> 08/05/2015

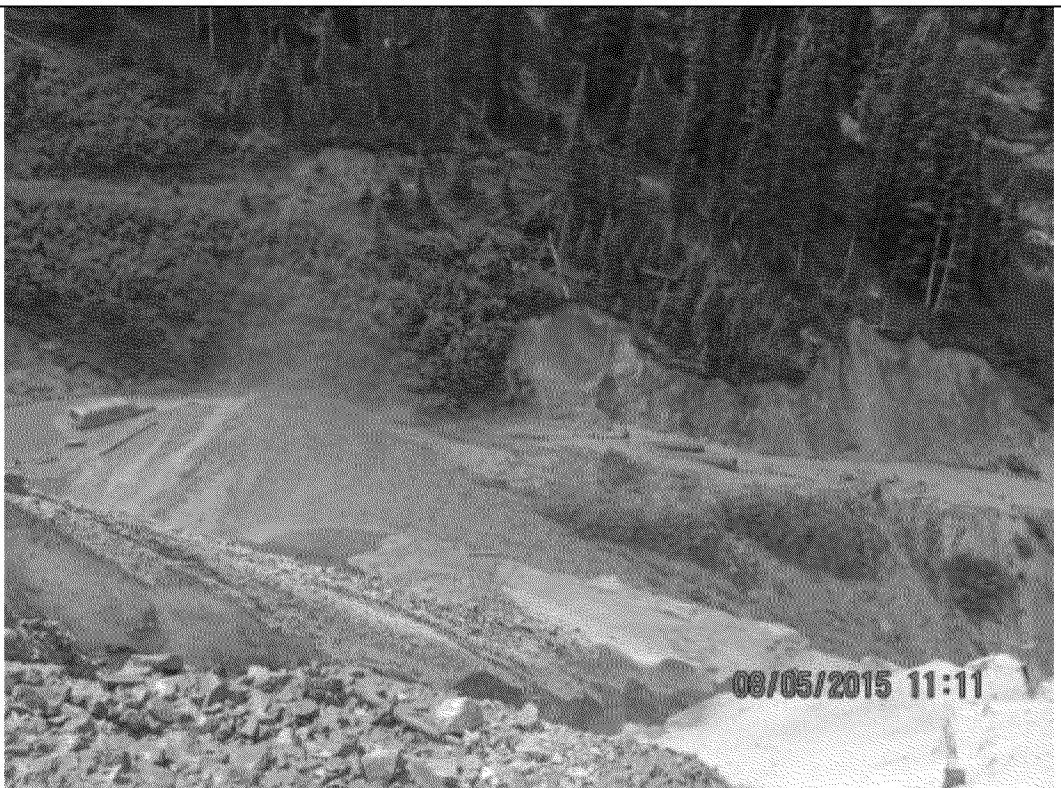
<b>Direction Photo Taken:</b>  Southeast		
<b>Description:</b> Water flow washing out the existing road. Note Suburban in left side of photo.

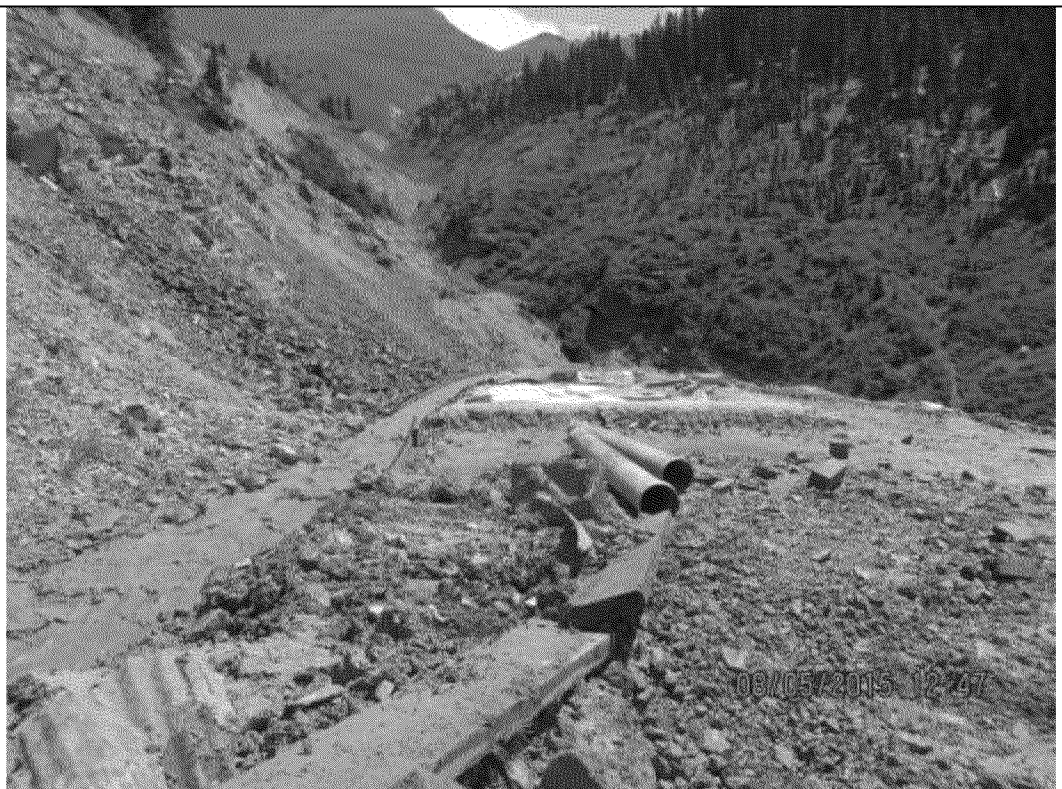
**Photo No.**  
**38**

Existing culvert flows subsiding minimally.

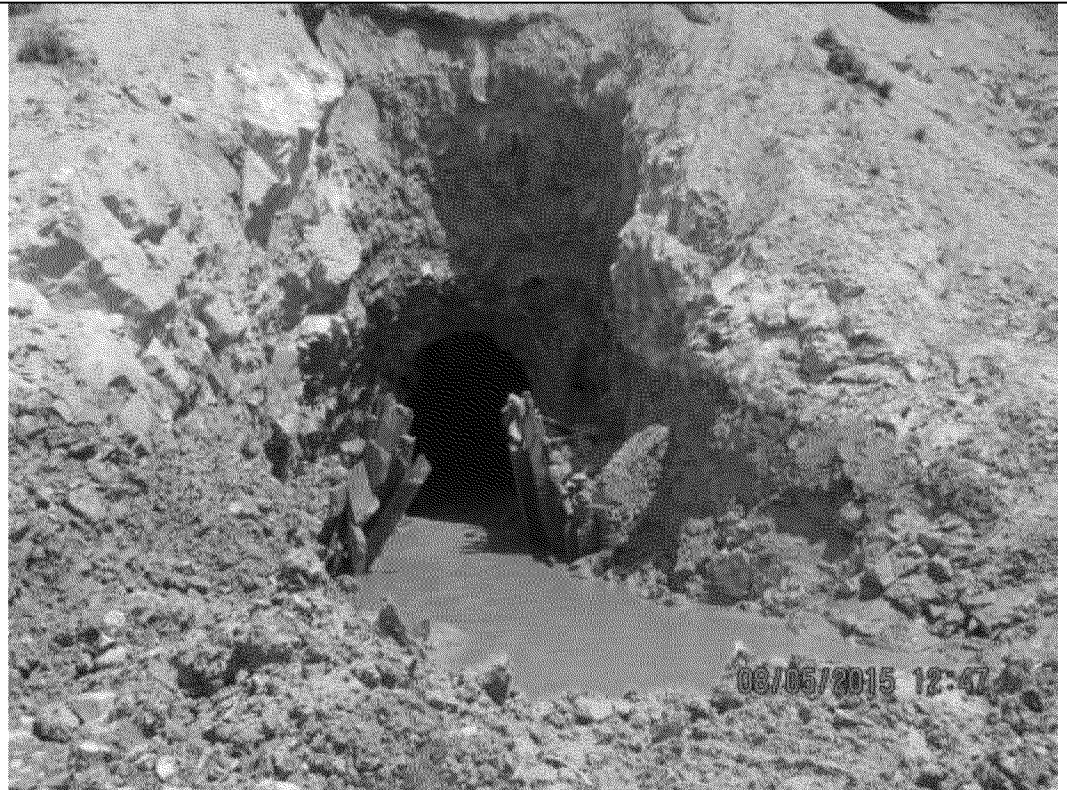
**Photo No.**  
**39**

No changes visible in adit structure or supports. Sloughing of materials inside the mine can be heard.

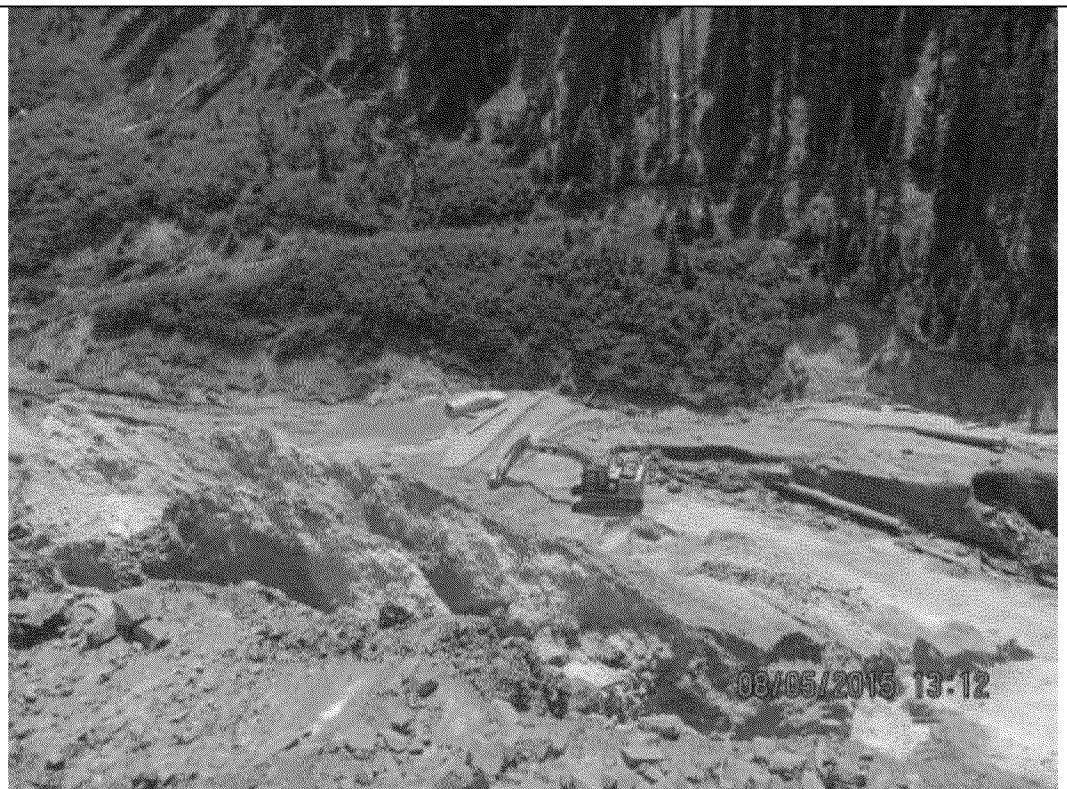
**Photo No.**  
**40**

Excavator progresses to washed out North Fork crossing.

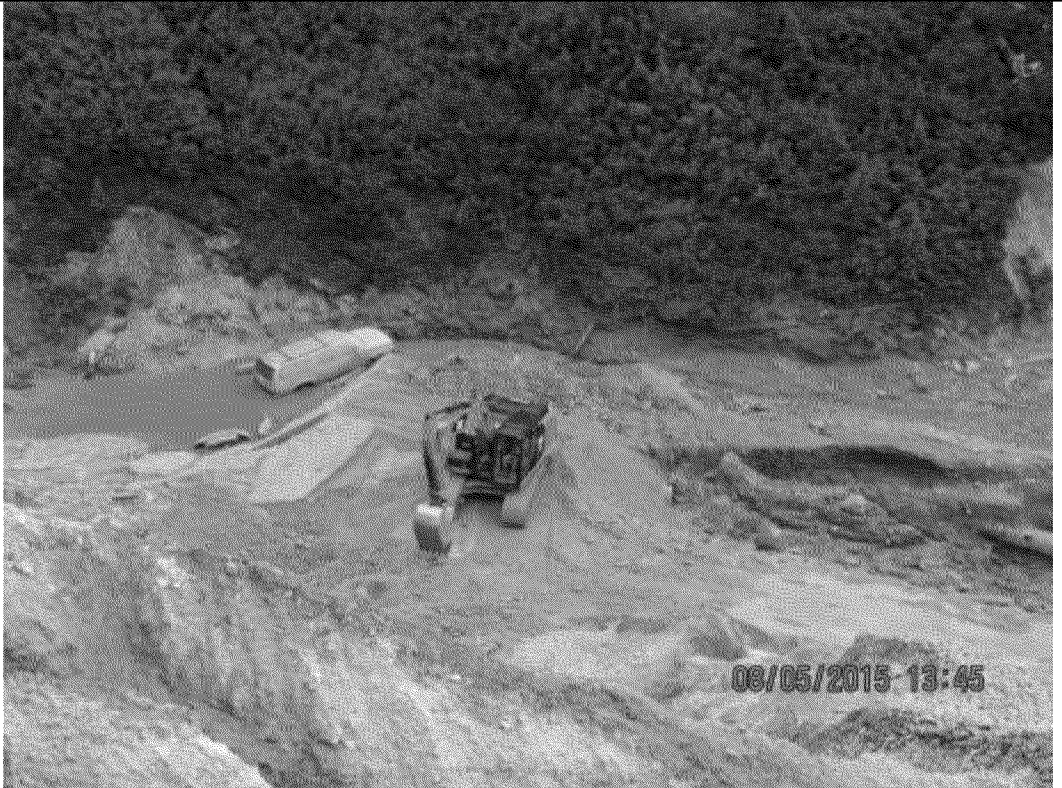
<b>Photo No.</b> <b>43</b>	<b>Date:</b> 08/05/2015

<b>Direction Photo Taken:</b>  South/Down		
<b>Description:</b> Excavator continues to fix access road. Continued high flow is slowing progress.		
<b>Photo No.</b> <b>44</b>	<b>Date:</b> 08/05/2015

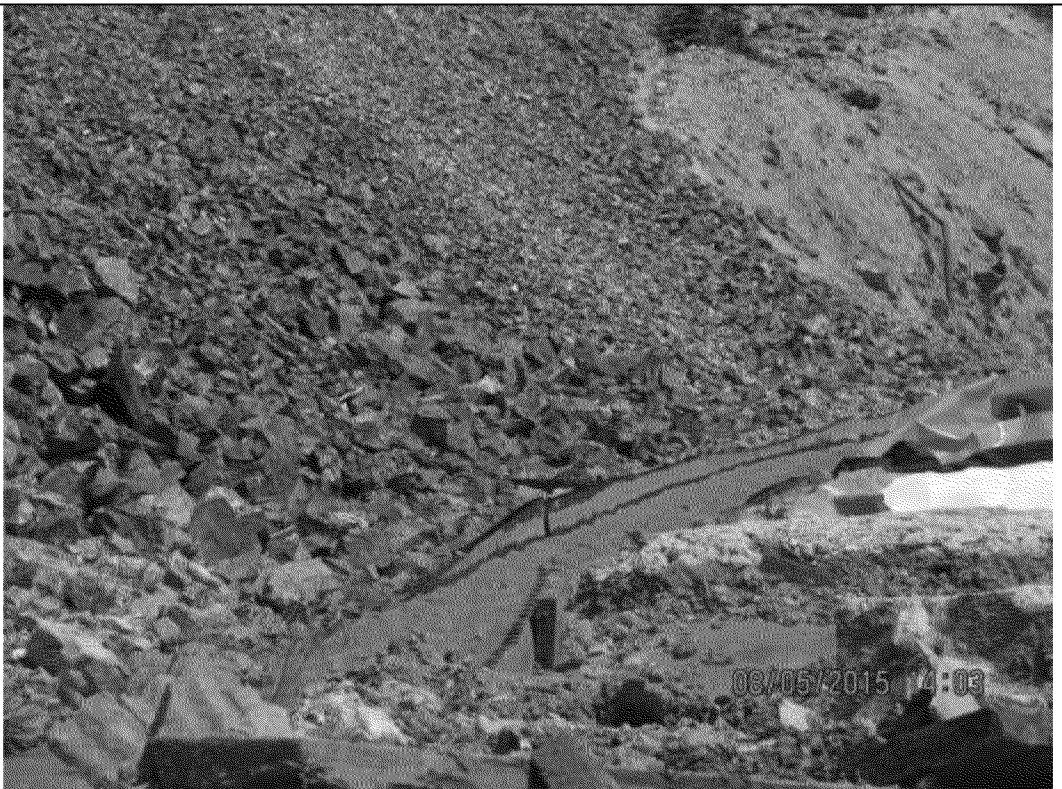
<b>Direction Photo Taken:</b>  East		
<b>Description:</b> Half culvert flow continues to subside.

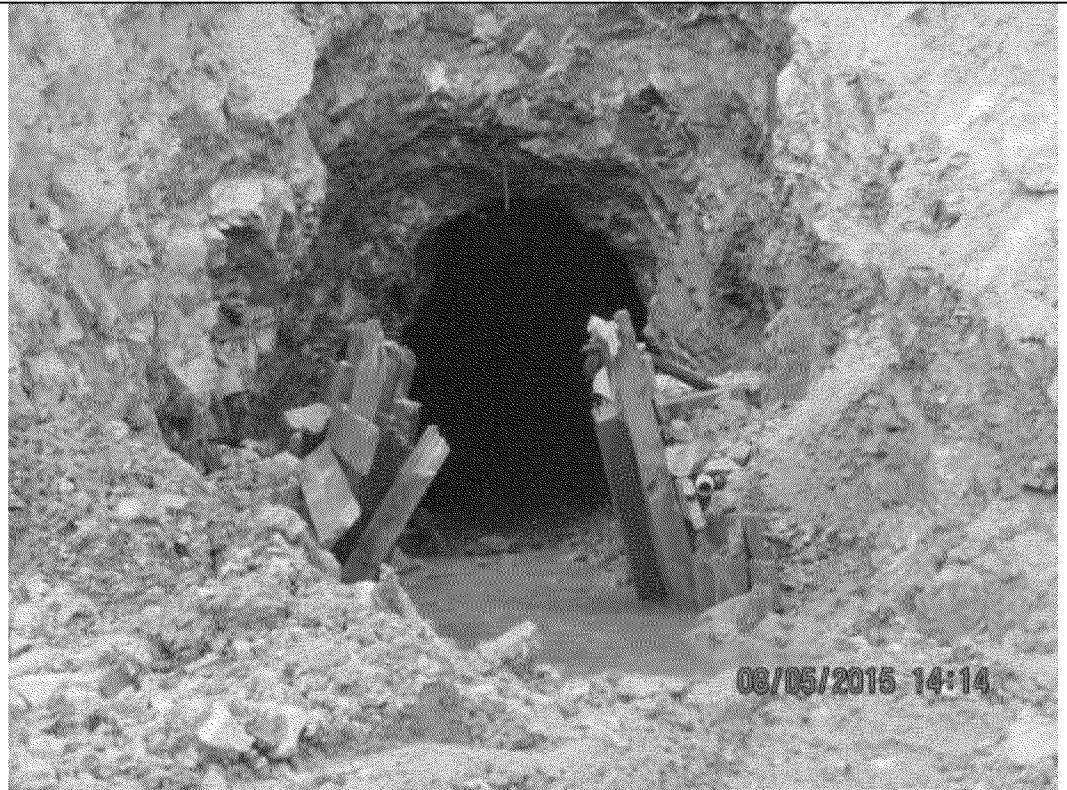
**Photo No.**  
**45**

Water levels lowering at adit entrance, no visible changes to structure.

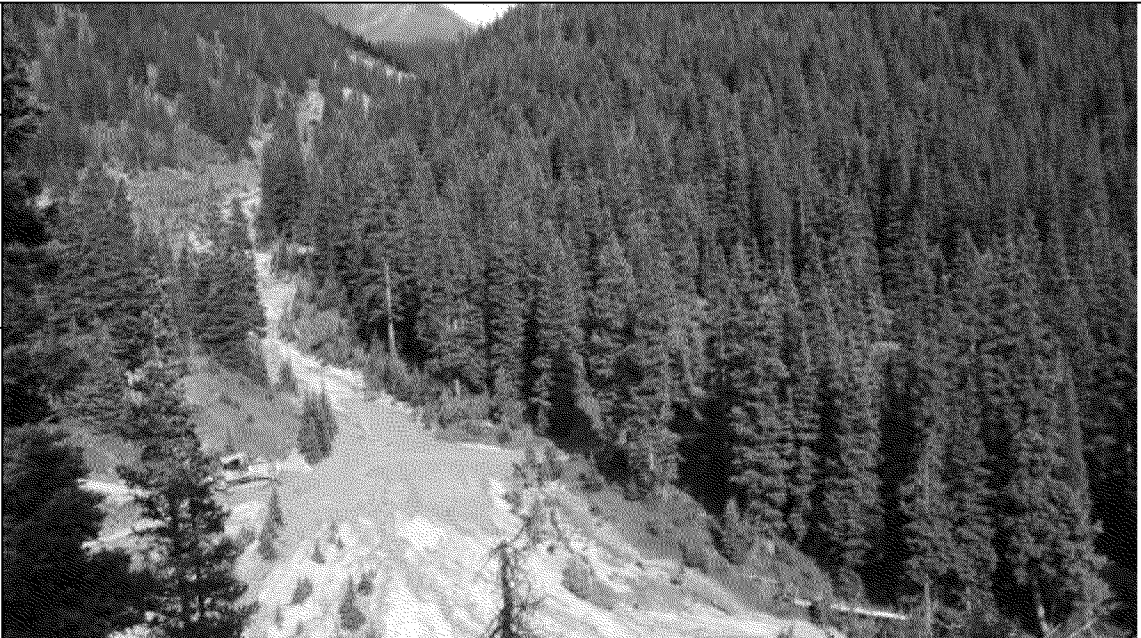
<b>Photo No.</b> <b>53</b>	<b>Date:</b> 08/05/2015

<b>Direction Photo Taken:</b>  East		
<b>Description:</b>  Looking east across Cement Creek from County Road 10 to excavator fixing County Road 52 at North Fork crossing just south of Red and Bonita Mine.
